## **Lake Christine Fire:**

***A Post-Fire Study on the Effectiveness of  
Wildfire Mitigation Activities in Identified Neighborhoods***

**August 2019**

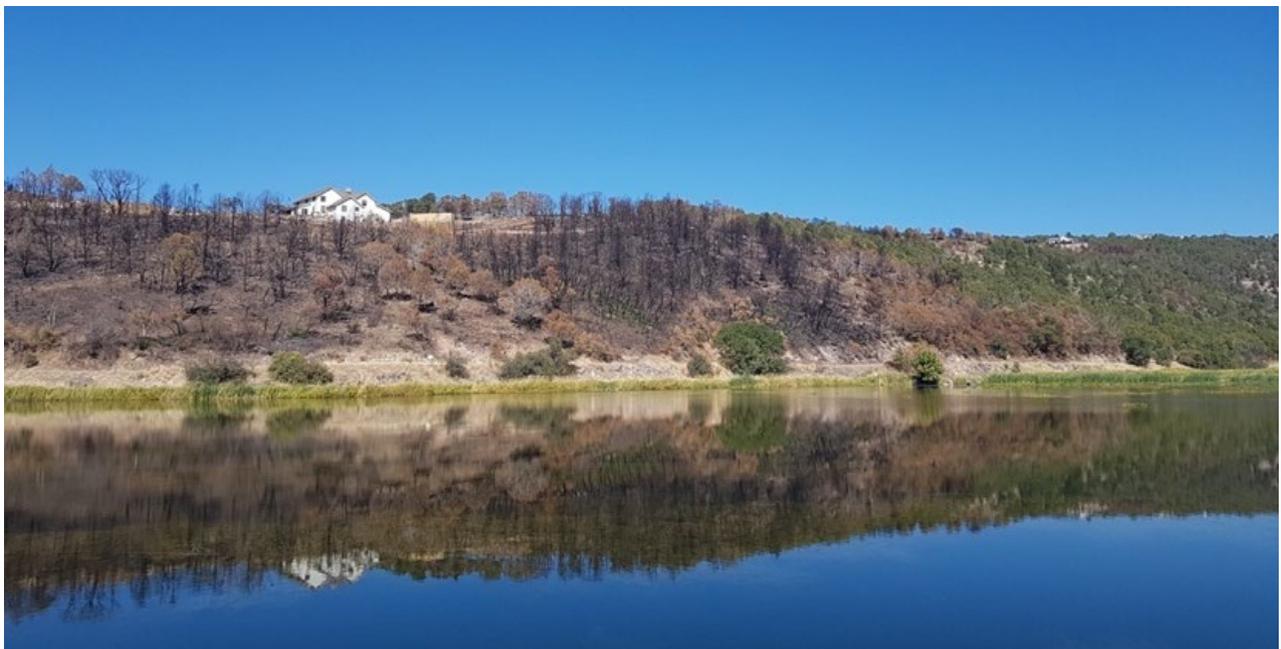
*Figure 1. Home survival was a result of both firefighter suppression and mitigation actions.  
Credit: Kelly Johnston*

This study determined that homes which survived the Lake Christine Fire can be attributed to a combination of suppression and mitigation actions. In some cases, such as the El Jebel Mobile Home Park, it is highly unlikely that many structures in this area would have survived without the level of structure protection resources that were in place. This conclusion is based on the lack of visible mitigation, prevalent examples of combustible materials in and around structures, and compact development patterns. In other cases, such as several properties in the Missouri Heights neighborhood, it is more likely that structures in this area could have survived with limited to no structure protection resources due to the varying degrees of mitigation and separation of structures from vegetation or other structures.

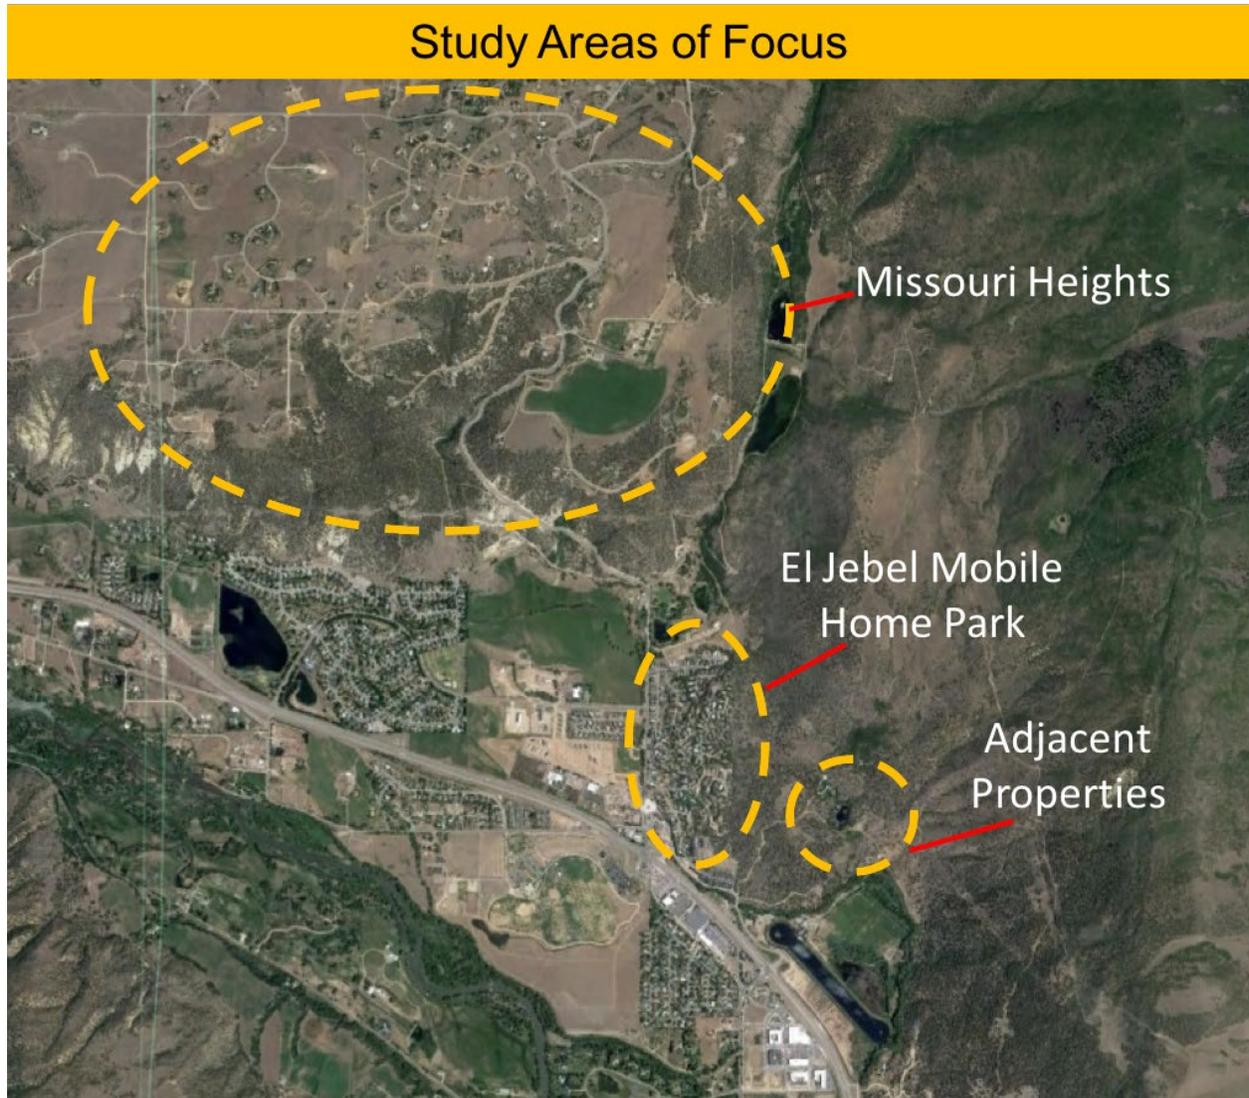
*Figure 3. This study is focused on two areas that were directly affected or threatened by the Lake Christine Fire: El Jebel Mobile Home Park and adjacent properties, and several neighborhoods in Missouri Heights.*

Specifically, the study area focuses on two WUI areas that experienced structure losses during the Lake Christine Fire: El Jebel Mobile Home Park and several adjacent properties affected by the fire, and a collection of properties and neighborhoods referred to as Missouri Heights (Figure 3).

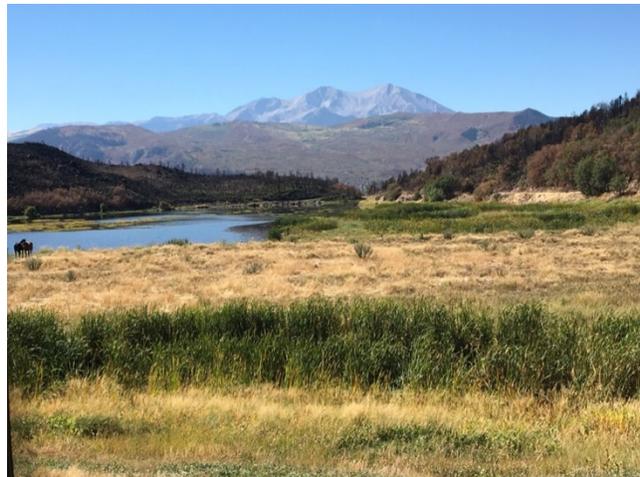
*Figure 6. Water features in the study area are ditch-fed reservoirs that run along an irrigation network.  
Credit: Molly Mowery*

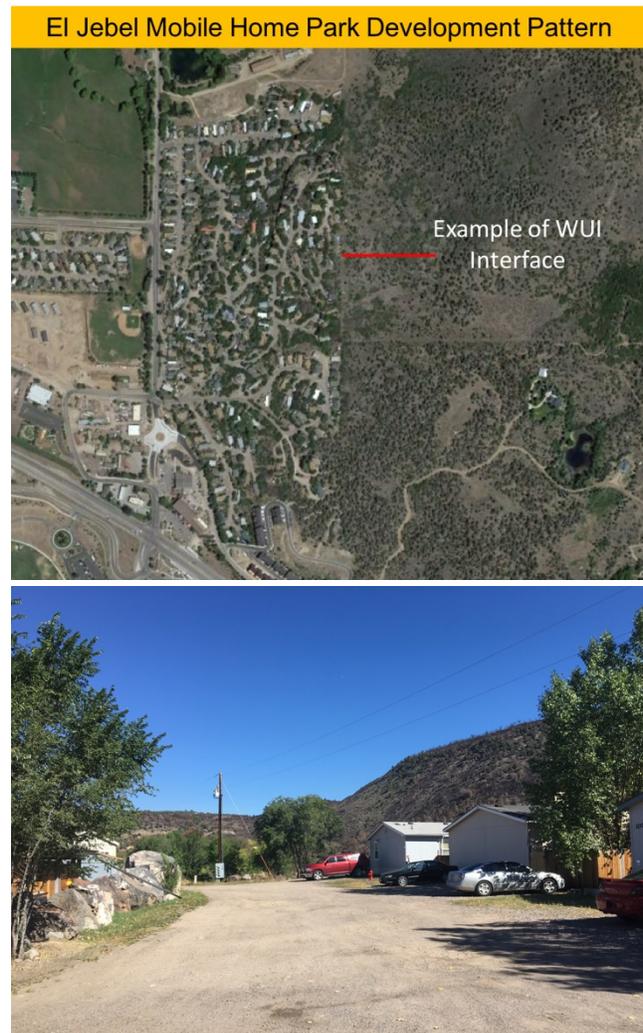
Figure 7. Development patterns in the El Jebel Mobile Home Park represents a WUI interface. Credit: Molly Mowery

Topography within the El Jebel Mobile Home Park is relatively flat. Property setbacks vary significantly—some distances between structures are less than 30 feet, while other distances are greater than 100 feet. Vegetation (trees, shrubs, grasses) is interspersed throughout the community, but generally the area represents an interface WUI due to the linear shape and defined edge in proximity to a wildland area (Figure 7).

Homes have either asphalt or metal roofs. Approximately 70% of the homes have lap siding (MHVillage n.d.). Foundations are typically covered/closed with metal, plastic or wooden trellis features. The presence of attachments (decks, wooden fences) and other materials (lawn chairs, bicycles) is readily observed throughout the neighborhood. Utilities are above ground.

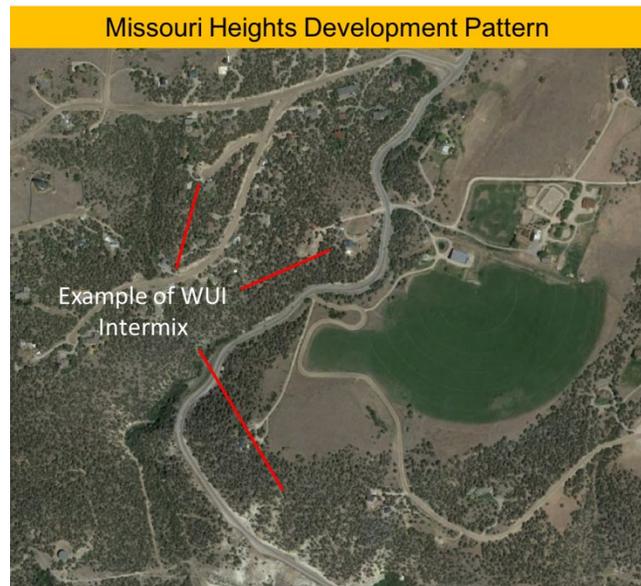
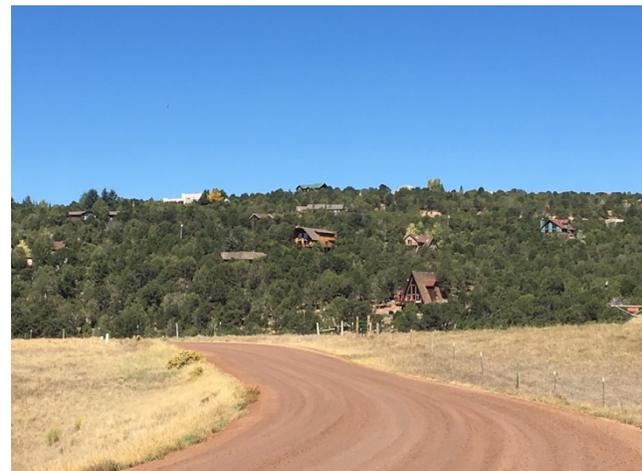
Figure 8. Development patterns in Missouri Heights represents a WUI intermix. Credit: Molly Mowery

fields or horse pastures. Structures are interspersed with vegetation, resulting in a WUI intermix (Figure 8).

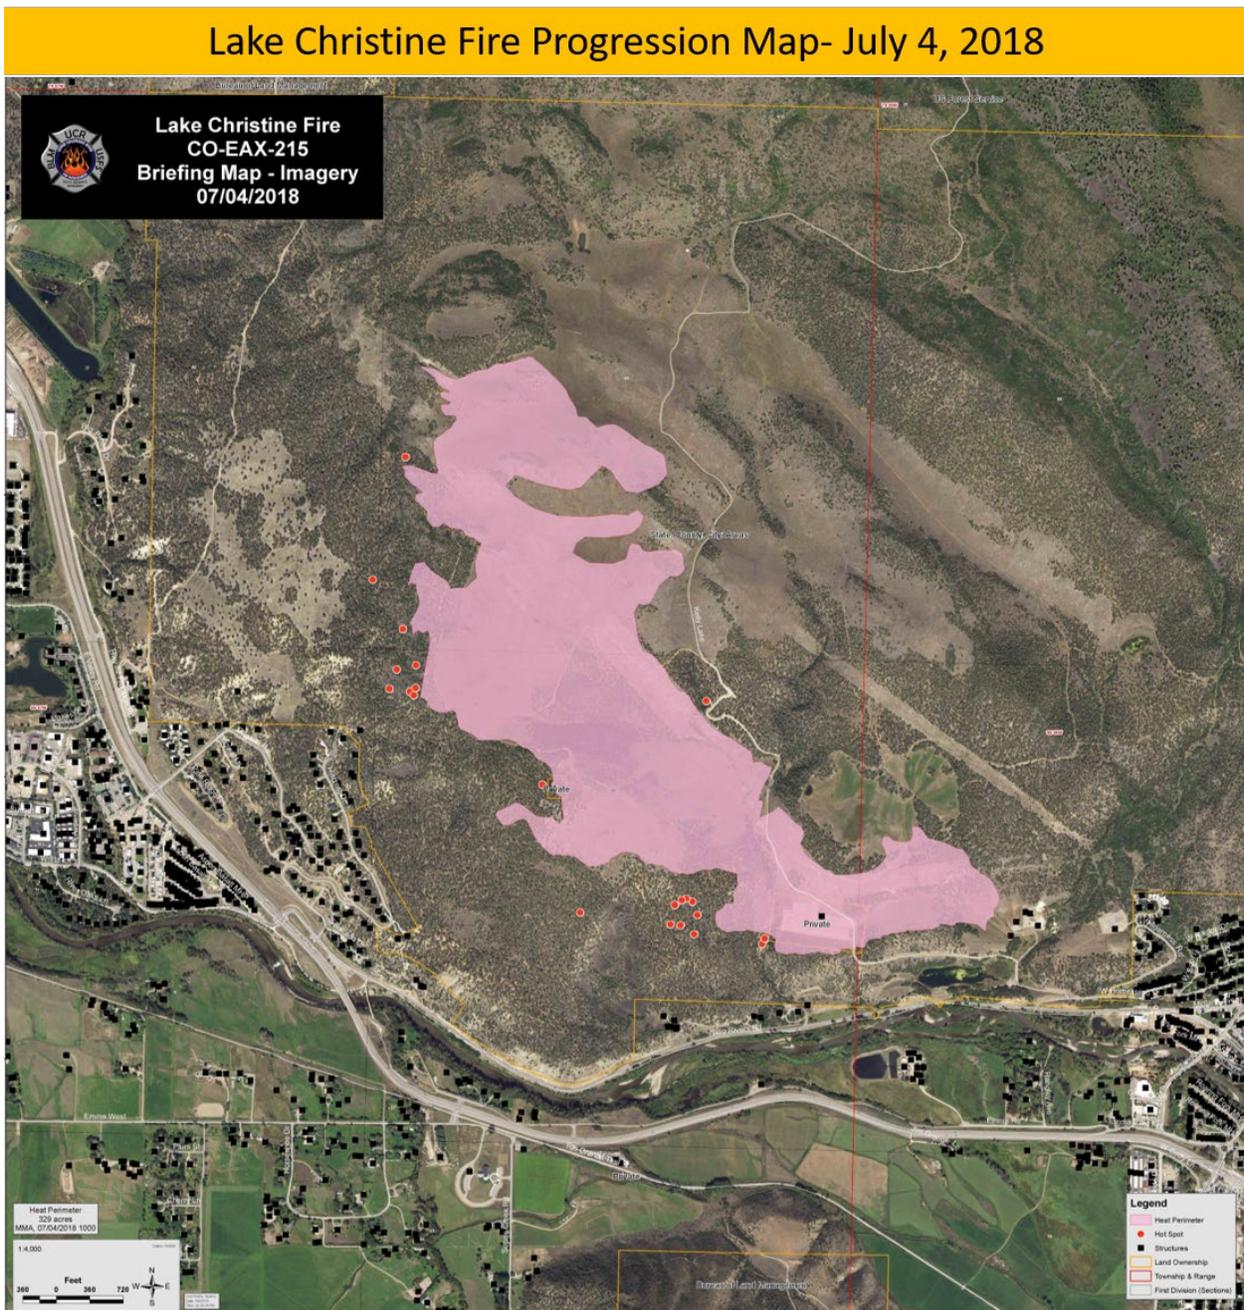
Figure 9. July 4, 2018 Lake Christine Fire Progression Map

According to the fire progression map (Figure 9), and interviews with fire suppression resources, initial fire spread was downhill, transitioning to following topography and upslope winds to the north and northwest and west through the late evening of July 4 and into the early hours of July 5. The fire continued to burn to the northeast and up the southwest facing slope of Basalt Mountain for the remainder of the incident.

The fire started on the southwest slopes of Basalt Mountain, progressing west along the south slope and finally north along the Blue Creek drainage and the southwest slope of the mountain. The south slopes of Basalt Mountain are characterized by generally moderate “benched” slopes transected by the north/south oriented Blue Creek drainage. The southwest slope of Basalt mountain becomes progressively steep moving north. The topography characteristic of the El Jebel Mobile Home park is generally flat; while the eastern flank of the Missouri Heights neighborhood is characterized by the relatively steep slope of the Blue Creek drainage.

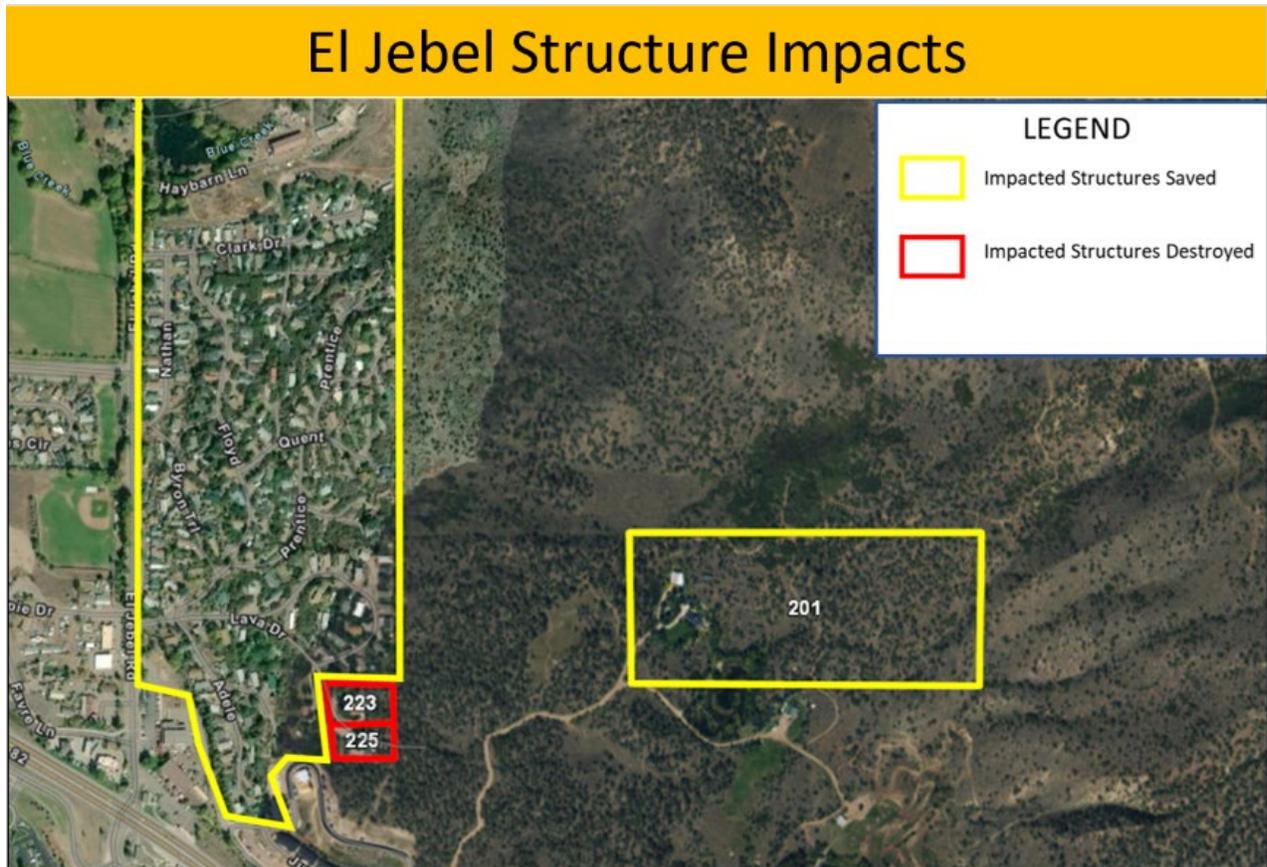
Figure 10. El Jebel Mobile Home Park and Tree Farm Drive impacted structures (saved and destroyed)

Suppression crews in this area reported initiating a burn-out operation to minimize the radiant heat potential of the flank and backing fire, as well as minimize the extent of ember exposure. The burning operations progressed from north to south along the eastern perimeter of the mobile home park. In addition to the burning operations, engine crews also patrolled and suppressed spot fires where embers landed and ignited within the neighborhood. The structure protection operations were successful in protecting all the structures within the mobile home park. Fire behavior at the south end of the neighborhood prevented the completion of the operation, and two structures on Lava Drive, immediately outside the park, were destroyed (Figure 10). Suppression resources who witnessed the ignition of these structures described the cause as a significant ember storm that ignited accessory buildings and decks, which in turn ignited the primary structures.

Fire suppression resources credited the prevalence of metal skirting, or at a minimum enclosed mobile home foundation in the area for resisting ignition from fire and increasing suppression opportunities. However, during a post-fire site visit, study authors noted several conditions that typically lead to structure ignition, such as combustible accessory structures, vegetation, and stored materials immediately adjacent to primary structures. The success of structure protection in this area is largely attributed to the ability of significant suppression resources to arrive from other jurisdictions and be able to engage prior to fire impingement.

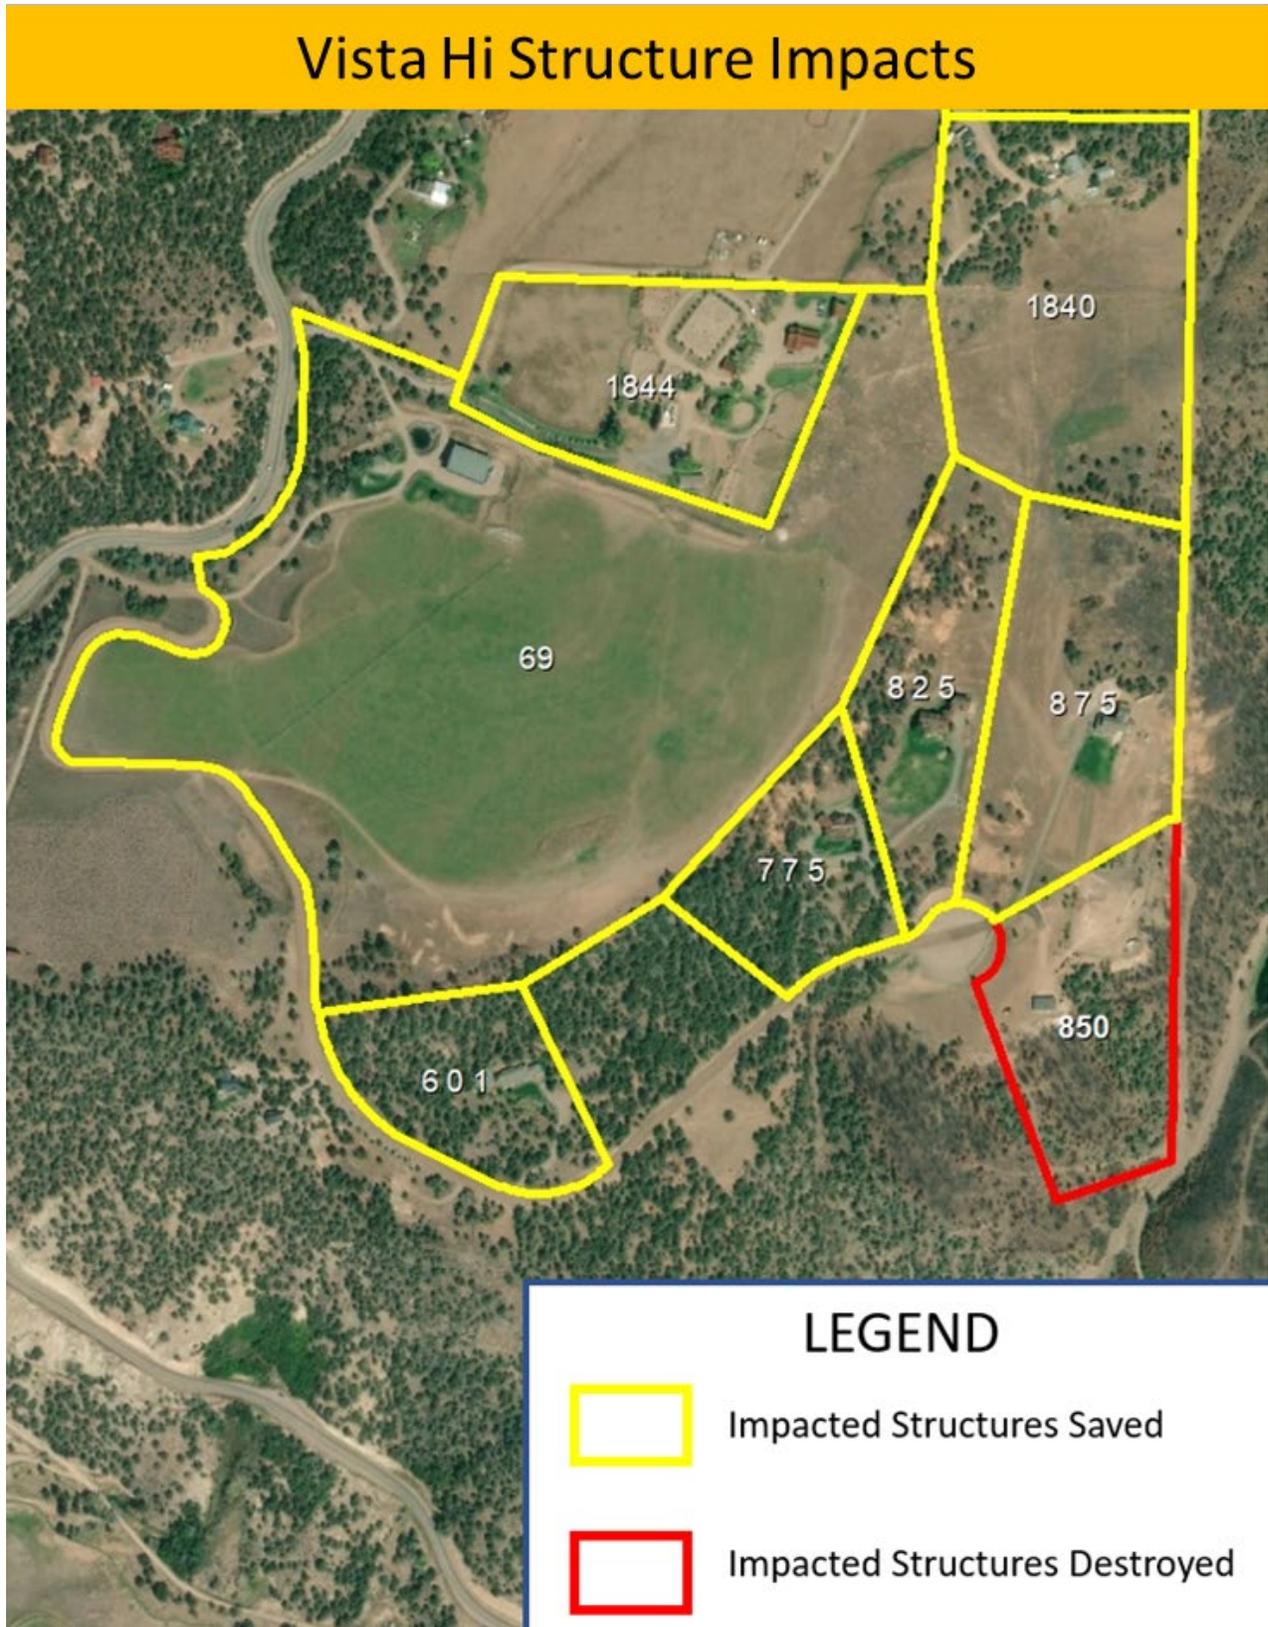
Figure 11. Vista Hi neighborhood impacted structures (saved and destroyed)

Subsequent to fire impingement on the El Jebel Mobile Home Park, the Vista Hi neighborhood was challenged by head fire radiant heat and ember impacts approaching from downslope of the 850 Vista Hi property from the Blue Creek drainage. Fire suppression resources reported that the structure was destroyed through ember ignition of accessory structures immediately adjacent and downhill of the primary residence, which, in turn ignited the primary residence. Suppression resources also reported significant ember showers produced by the burning structures that ignited spot fires in hay fields, grass, and Pinyon-Juniper stands over five hundred feet down wind (to the west and northwest). A large, irrigated field located directly west of Vista Hi was attributed to halting fire spread to the west (Figure 11).

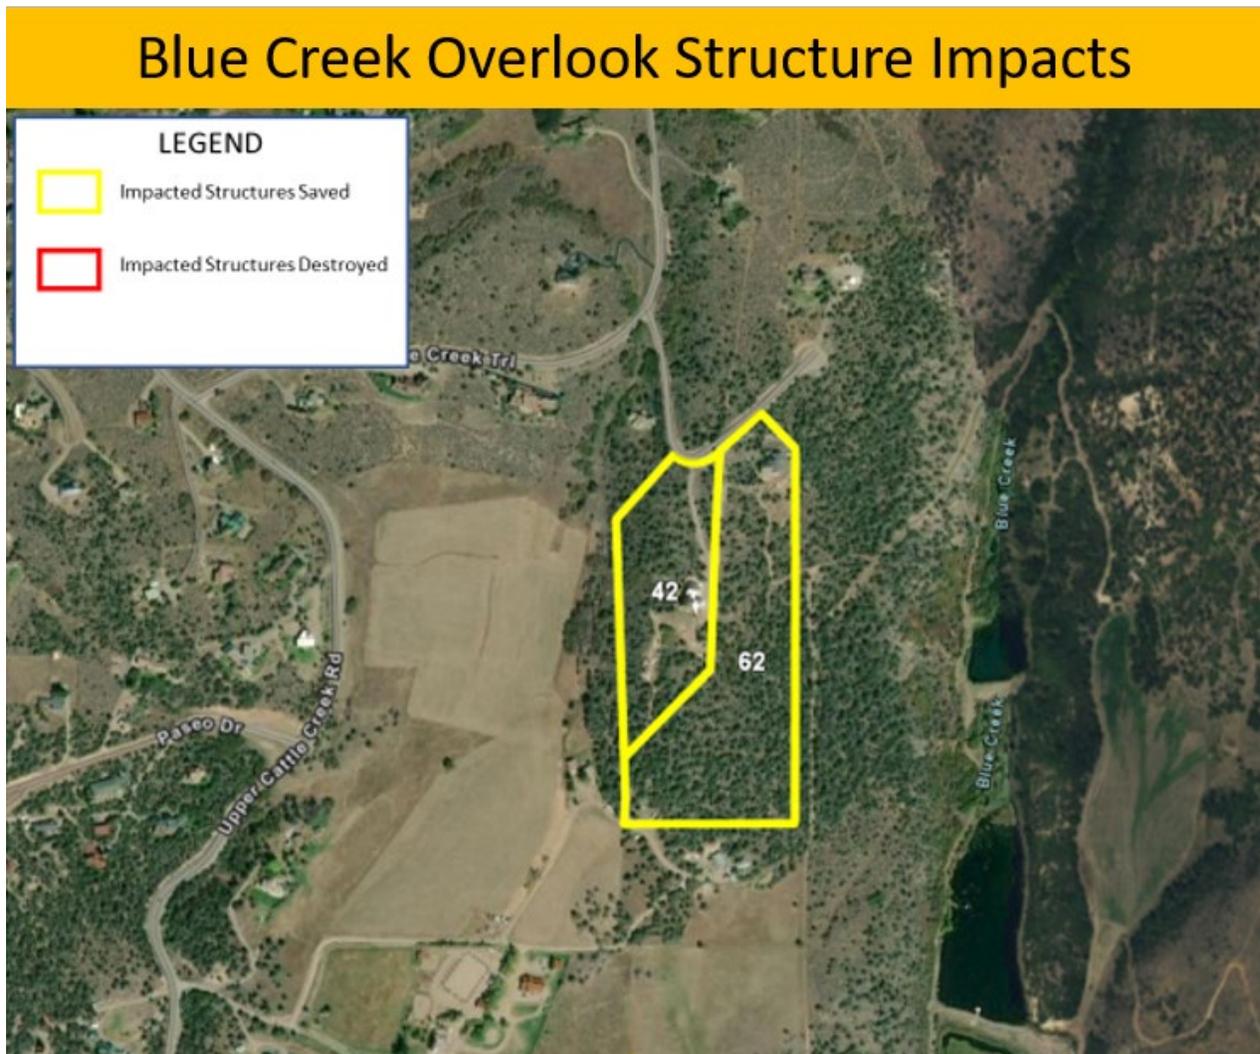
Figure 12. Blue Creek Overlook impacted structures (saved and destroyed)

As the fire spread to the north, up the Blue Creek drainage and along the southwest aspect of Basalt Mountain, a significant spot fire was generated by embers approximately 800 feet ahead of the fire front. The spot fire quickly grew, impinging upon two properties in the Blue Creek Overlook neighborhood. Due to the fire activity, limited area knowledge, and inability to adequately assess the situation in the dark, fire suppression resources staged outside the properties to wait for a decrease in fire activity. Upon entry to the properties, firefighters found no structure damage. Therefore, both properties survived without fire suppression intervention (Figure 12).

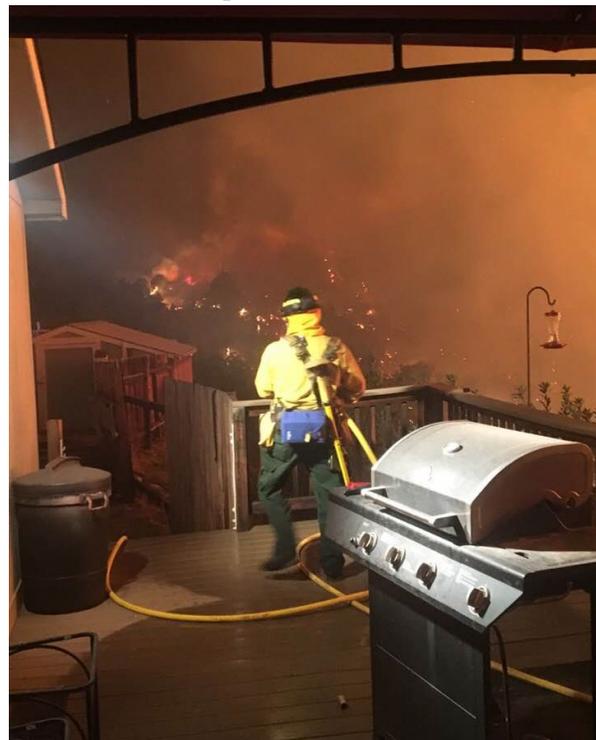
*Figure 13. Firefighter taking suppression actions on Lava Drive. Credit: Chief Doug Cupp*

- **Firefighter response.** It cannot be emphasized enough that actions taken by firefighters in both study focus areas were the primary reason why so many structures survived. These actions included both experienced response tactics (Figure 13) and additional mitigation activities taken by crews (e.g., cutting down trees, moving firewood piles away from homes). The community was fortunate to have both a number of trained firefighters and equipment available to respond; between local resources and mutual aid firefighters available from other fire districts. This circumstance, however, cannot be relied on for future wildfire incidents, especially when other active fires across the state or country pull local resources away. Property owners should therefore proactively take all mitigation measures well in advance of a wildfire threat.

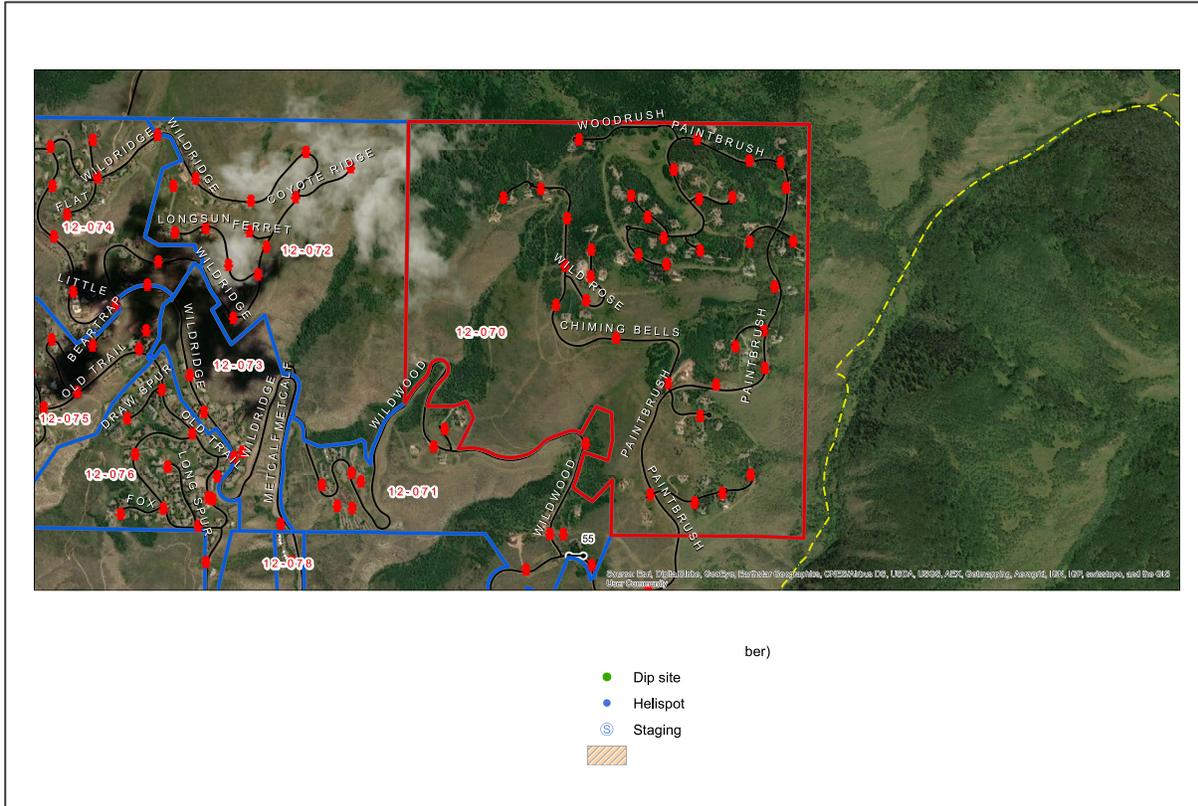
Figure 14. An example from the Lake Christine map book

- **Pre-suppression planning.** As noted, many fire suppression resources interviewed indicated that they were not familiar with the local neighborhoods in which they were providing response. They also did not have adequate spatial tools (maps) to show the location or number of structures, which meant they could not always understand where to prioritize patrolling or other placement of resources. There is an existing map book for the I-70 county corridor (see Figure 14); expanding the map book across the county to develop a comprehensive pre-planning spatial analysis would increase the ability for outside resources to efficiently and safely respond in the future to all areas.
